# CeSARUS Modem

## LOCOSTO Processor Silicon Errata

## LOCOSTO Silicon Errata

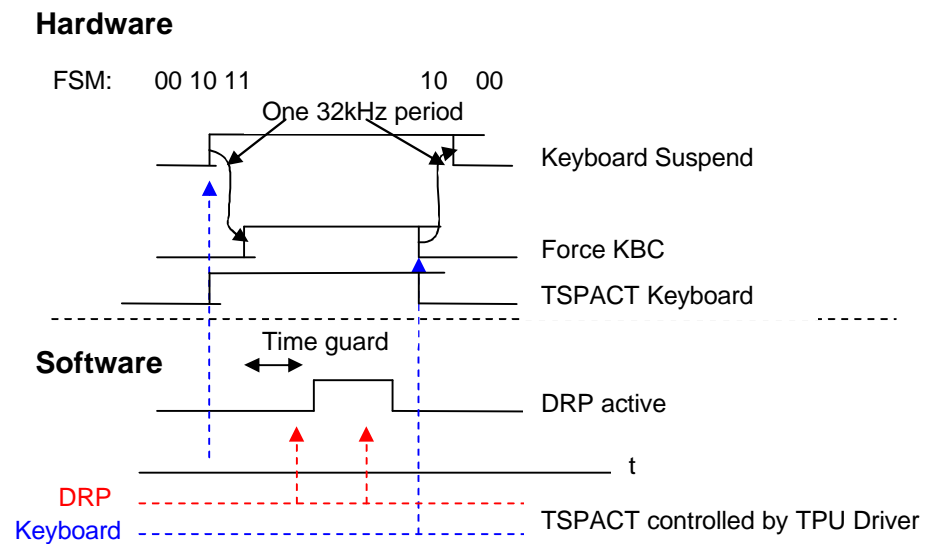
**Figure 1: Keyboard / XTAL interaction workaround principle**

When a keyboard key is pressed the DRP PLL has an out of specification phase error.

The root cause is a coupling between XTAL and keyboard signals.

This coupling occurs at chip substrate level and may be increased by routing on board if XTAL track is close to keyboard tracks.

The principle is to prevent keyboard scan activities while RF activity (DRP active).

In ES2.0, the internal TSPACT4 controlled by TPU is used to hold the keyboard activity while the DRP is active (both RF TX and RX activities).

The Figure 1 illustrates the principle of the workaround.

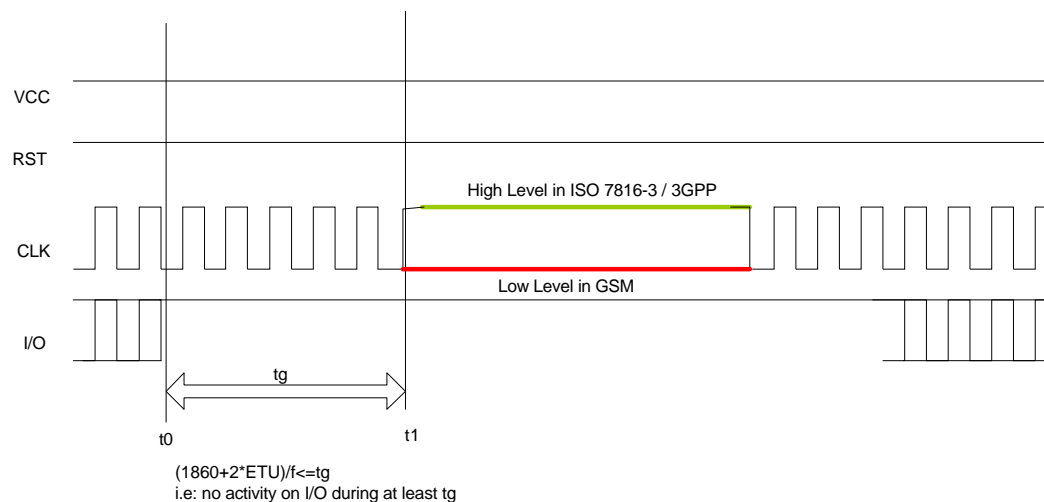
**Figure 2 Clock stop sequence**

When using the Clock Stop mode whose purpose is to stop the USIM card clock (*sim\_clk*) to save power while in transmit mode, it sometimes happens that the USIM FSM gets stuck in NC\_PWR\_OFF state.

When the command bit 5 (CLOCK\_STOP\_CMD) of USIMCMD register is set to 1, the clock stop mode is activated and the USIM FSM is in the CLOCK\_STOP state. The CLOCK\_STOP\_CMD bit must be reset to 0 to exit this CLOCK\_STOP state and enter the CLOCK\_RESTART state. However it sometimes happen that after resetting the CLOCK\_STOP\_CMD bit, the FSM goes to WARM\_RESET state which finally drives the FSM to the NC\_PWR\_OFF state (Not Connected state).

The purpose of this workaround is to control by SW the clock stop sequence; therefore the workaround is split in 2 parts, one related to the Clock Stop sequence and another one related to the Clock Restart sequence.

- Clock Stop sequence:
  - Set bit 5 (CLOCK\_STOP\_CMD) of USIMCMD register to '1'
  - Wait till the FSM is in CLOCK\_STOP state
- Clock Restart sequence:
  - Set bit 8 (SOFT\_NHARD\_FIDI\_PROG) of CONF5\_REG register to '1'  
=> Switch to SW configuration
  - Set bit field 11:0 (SAM1\_DIV) of CONF\_SAM1\_DIV register to '0x000'
  - Wait during (1024 \* 20.CPU CLOCK cycle) which is the worst case of HW configuration
  - Set bit 3 (MODULE\_CLK\_EN) of USIMCMD register to '0' to deactivate the module clock

- Set bit 5 (CLOCK\_STOP\_CMD) of USIMCMD register to '0'
- Set bit 8 (SOFT\_NHARD\_FIDI\_PROG) of CONF5\_REG register to '0'  
=> Switch back to HW configuration
- Set bit 3 (MODULE\_CLK\_EN) of USIMCMD register to '1' to reactivate the module clock.

Start the clock-stop sequence within 1860 Sim clock cycles ( $T_g$ ) from the end of the last character (typically a received character) to ensure that the FSM entry to CLOCK\_STOP state is triggered by the internal  $T_g$  timer expiry, and not the programming of CLOCK\_STOP\_CMD.

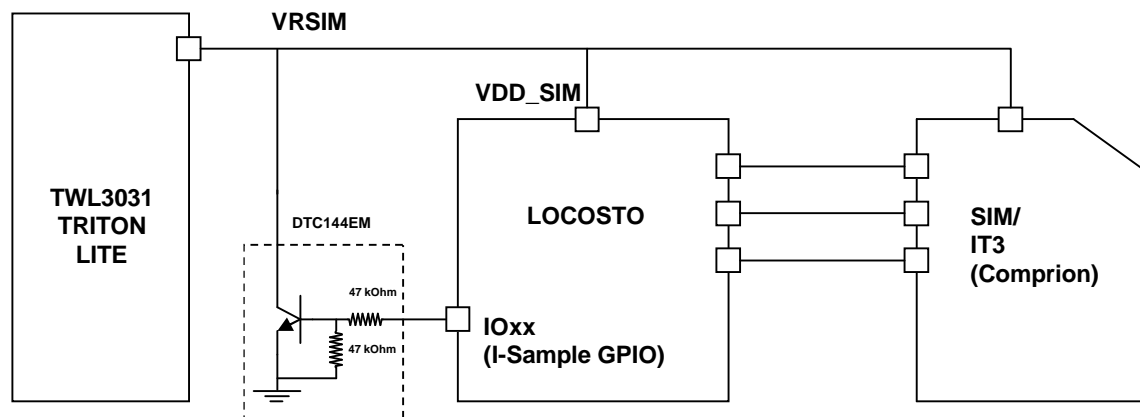
Figure 4: Electrical SIM FTA test failure – External transistor schematics

There is a leakage path through pad internal ESD diodes between USIM IOs (USIM\_RST, USIM\_IO and USIM\_CLK) and VRSIM power supply.

Due to that injection of current from SIM IT3 test equipment on USIM IOs before VRSIM is activated (Triton Lite VRSIM LDO is OFF), current flows from USIM IOs to VRSIM through the ESD diode leakage path.

When activating VRSIM (Triton Lite VRSIM LDO switched from OFF to ON), the DC offset on VRSIM causes overshoots on VRSIM in both 1.8V and 3.0V cases.

These changes will increase the DC offset on VRSIM before its activation. They will cause the overshoots to be over ETSI authorized limits causing failures on SIM FTA electrical test cases 27.17.2.1.1 and 27.17.2.1.2.

The recommended external transistor part number to use is the "DTC144EM".

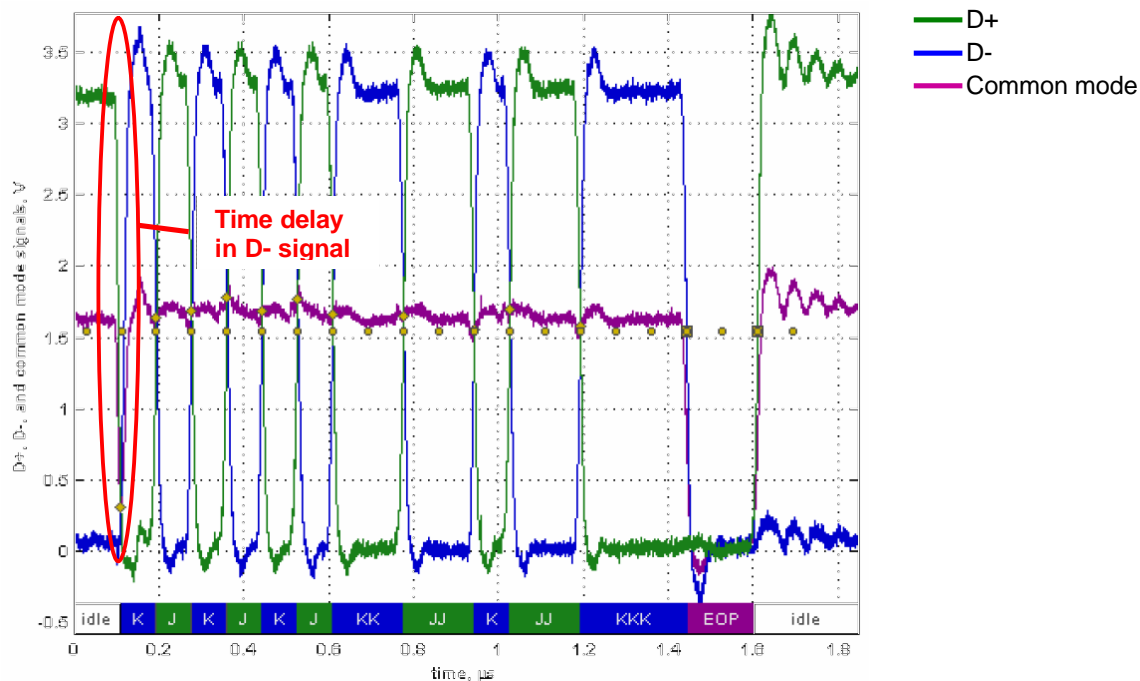
Figure 5: USB synchronization bit violation

USB synchronization bit violation during USB certification.

Test house waives the bit violation as it is only due to the first synchronization bit, repeated 5 times at the beginning of each packet.

During the first synchronization bit of packet, there is a time delay in USB D- signal. D+ signal goes down before D- goes high causing a bit violation.

Figure 5 shows the USB first synchronization bit violation.
