Errata and Restrictions

GT-64260-B-0

This document outlines all of the known errata that exist in the GT-64260-B-0.

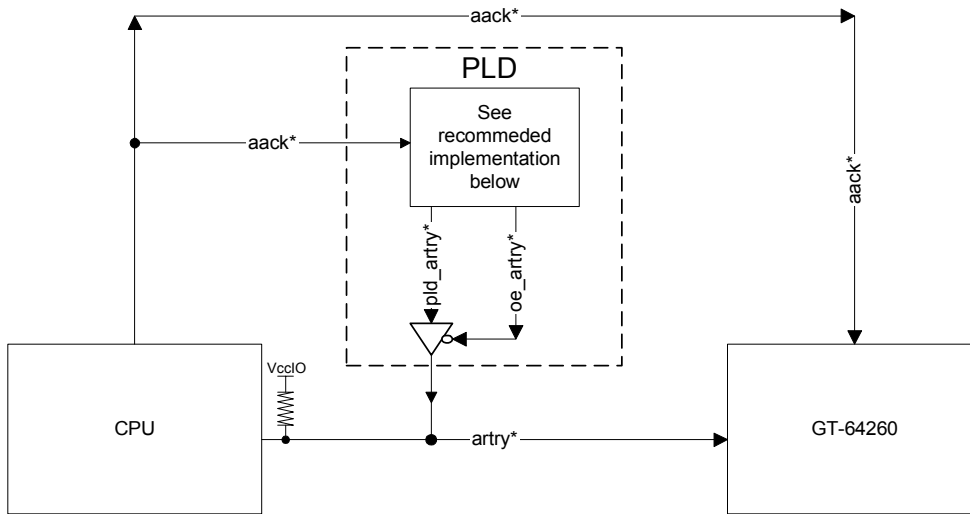
Figure 1: External Logic Block Diagram

- a) The GT-64260 is configured to 60x bus mode. Either by the Reset sampled pins (AD[7:6] == '00') or through the Serial ROM Initialization (Register 0x120, bits [7:4] == 0x4).
- b) The GT-64260 is configured (by default) to delay the AACK* assertion at least two cycles after TS* assertion (AACK* delay mode). (Register 0x000, bit [11] == '1')
- c) An external logic on the 60x bus negates the ARTRY* at the de-assertion cycle. Figure 1 describes the recommended external logic.

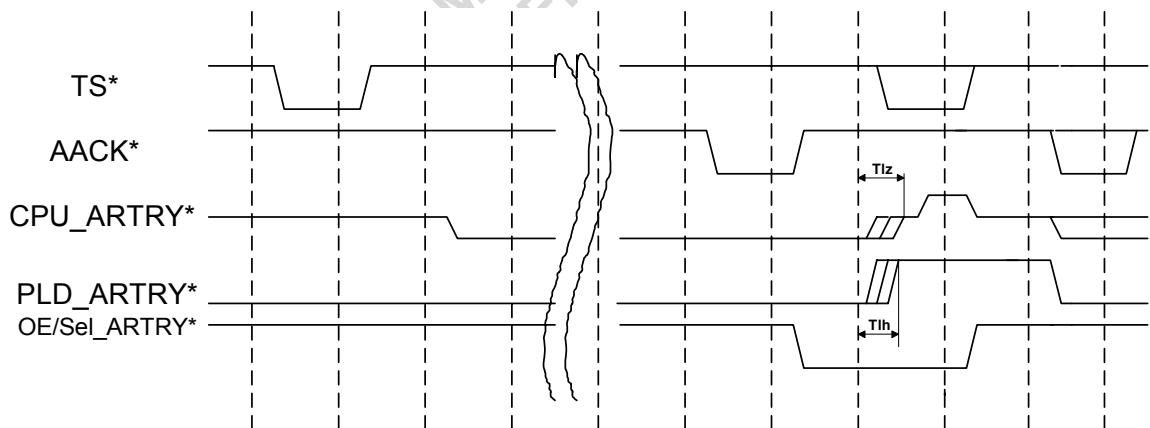
Figure 2: External Logic Timing Diagram

Figure 2 describes the signal timing for the above work around. To prevent contention on the ARTRY* signal, the system implementation must guarantee that $T_{lh}(\min) > T_{lz}(\max)$, while T_{lz} is the CPU clock to high-Z and T_{lh} is the clock to out of the PLD.

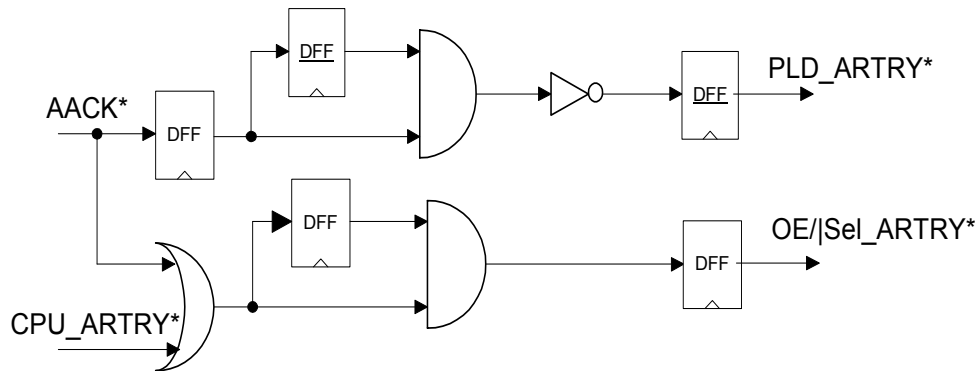
Figure 3: Recommended External Logic Implementation

When the $T_{lh}(\min) < T_{lz}(\max)$, the contention can be prevented by replacing the tri-state buffer with an external quick switch. In this configuration the Oe_ARTRY^* is used as the select for the quick switch device (Sel_ARTRY^*).

Figure 3 describes the recommended external logic implementation with a tri-state buffer and a quick switch device.

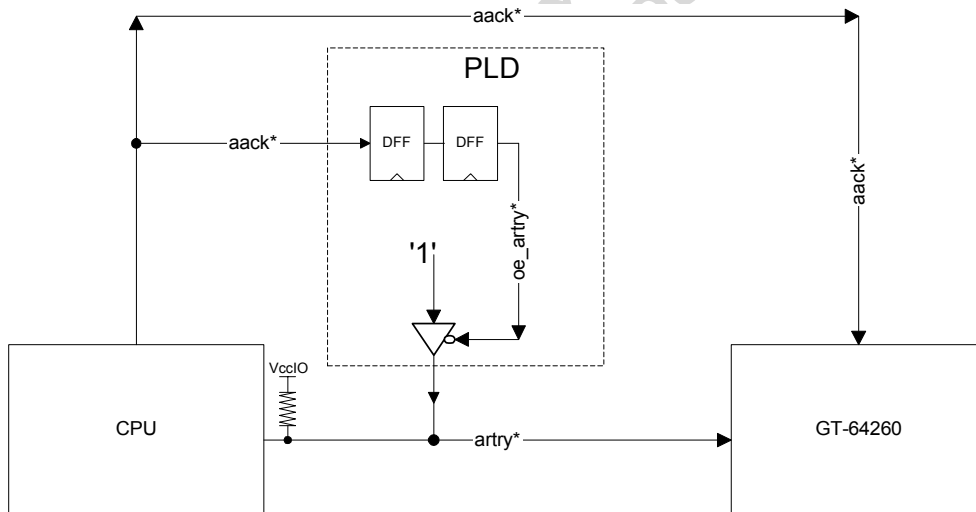
Figure 4: External Logic Block Diagram

In all systems that none of the above solutions works around the problem, implement an external logic that will force the negation of the ARTRY* during the de-assertion cycle by the CPU. Figure 4 describes the recommended external logic.

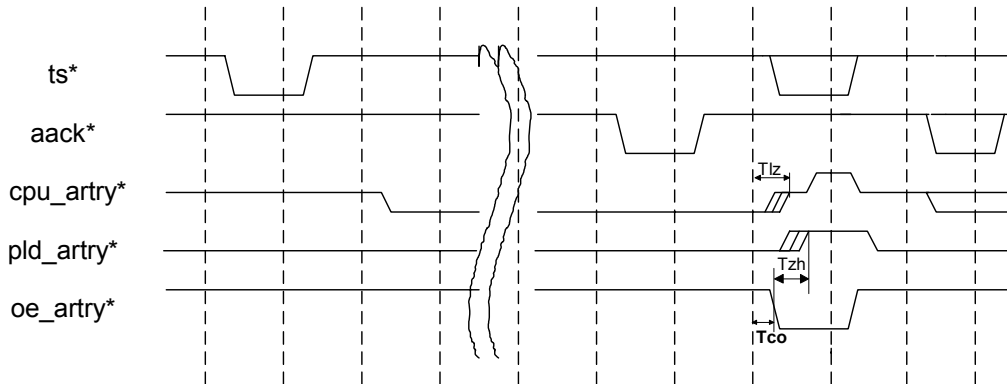
Figure 5: External Logic Timing Diagram

Figure 5 describes the signal timing for the work around.

NOTE: The timing of the output enable to out of the tri-state buffer (Tzh) must meet the ARTRY* the GT-64260-B-0's setup time. The calculation of the maximum clock frequency is calculated as follow:
