Title: How to debug power consumption issues

1.0 Introduction

This document mainly discusses debugging approaches of power consumption issues. It introduces power consumption testing procedure, HW/SW debugging steps and shares some customer power consumption issues on TI chipset platform.

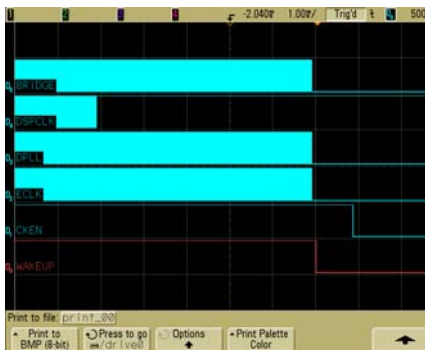
Figure 4.0 Locosto signals – ACTIVE to DEEP SLEEP sequence

Please be noted on some versions system can not go into deep sleep if USB cable are connected.

When testing UART version with trace enabled, it's better to plug in UART cable after system has reset and is into idle state.
